## APPENDIX G – Examples of Greenline Locations

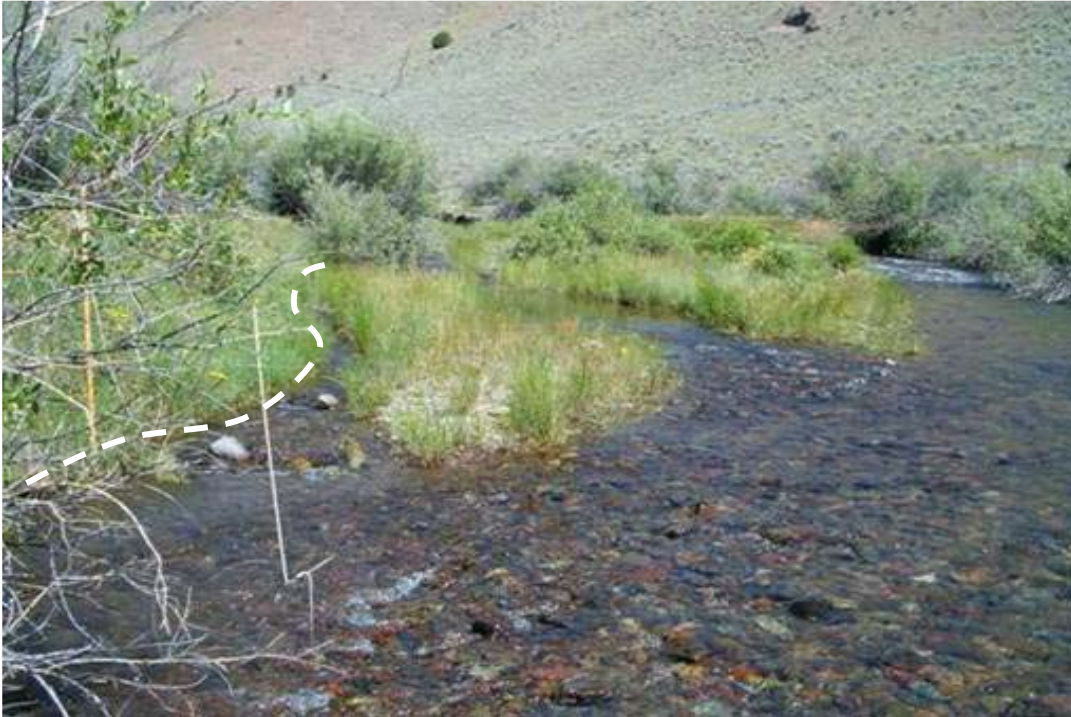
**Figure 17**—the greenline follows the outer streambank at bankfull. It does not cross a channel to the island. A small channel runs along the island on the left. Photo - PIBO, U.S. Forest Service

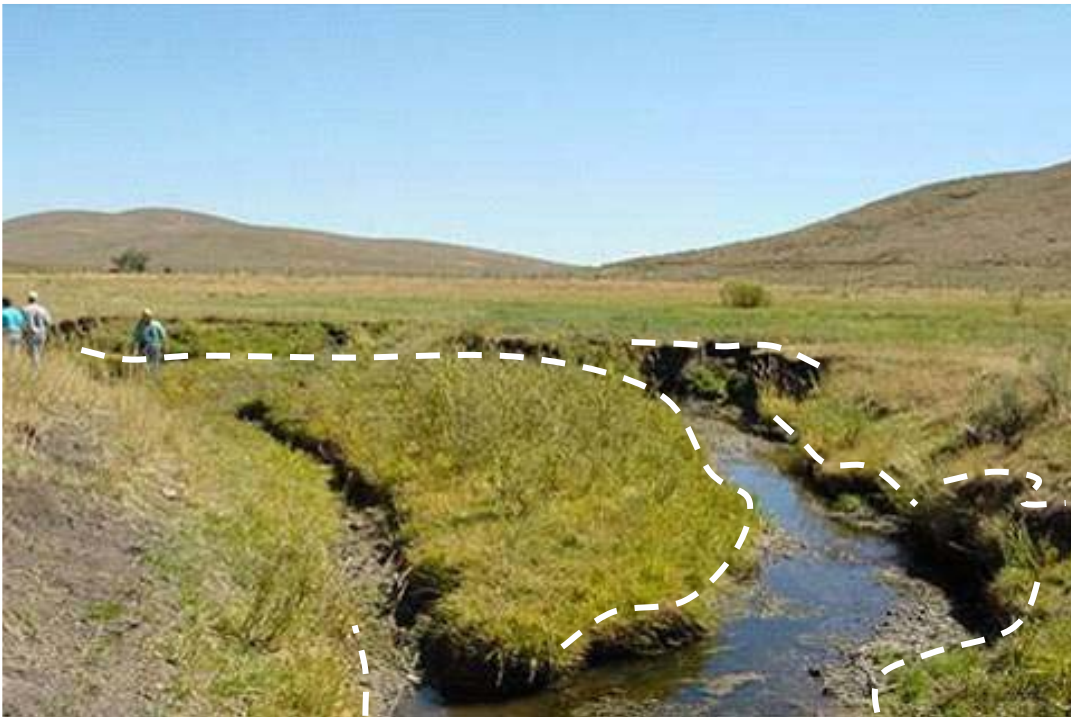
**Figure 18**—the greenline follows the vegetation line along the main channel because sediment deposition with vegetation block at the lower end of the channel. If an active channel continued creating an island, the greenline would follow the left bank along the smaller channel.

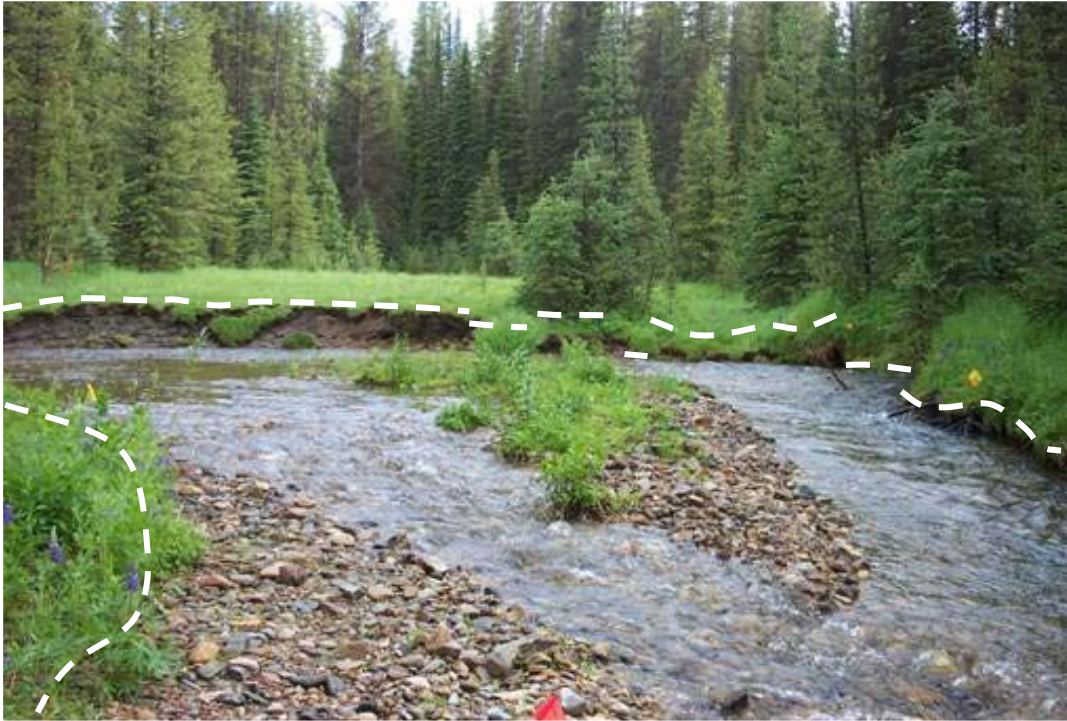
**Figure 19**—the island, even with vegetation is not part of the greenline. The slump blocks on the far bank are not counted as greenline because they still in a non-stable state. Photo - PIBO, U.S. Forest Service

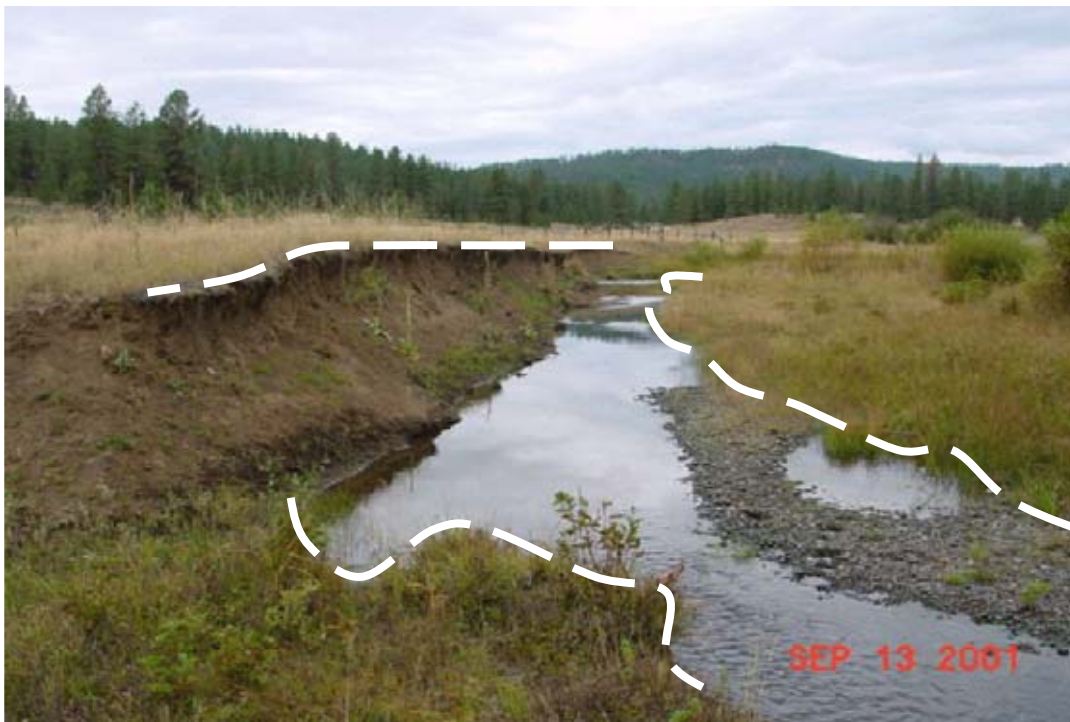
**Figure 20**—greenline on the left side of the photo is in two segments, the lower segment near the water's edge and the upper segment along the edge of the terrace with upland vegetation. The greenline on the right side of the stream is continuous along the perennial vegetation.

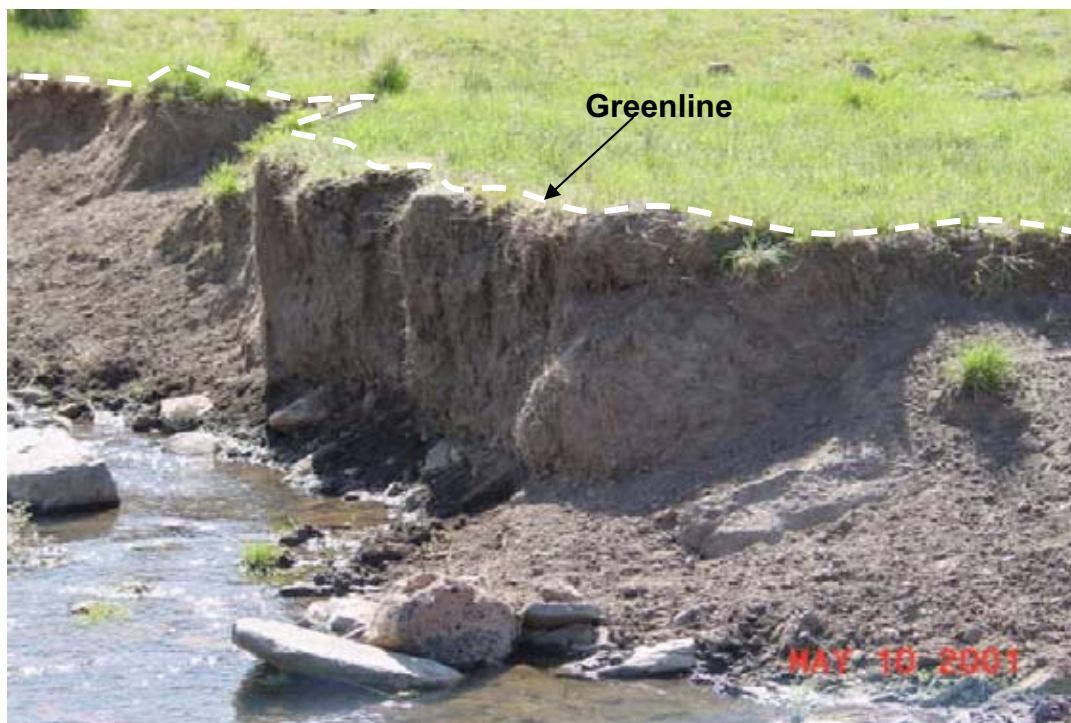
**Figure 22**—greenline on top of the 1<sup>st</sup> terrace.

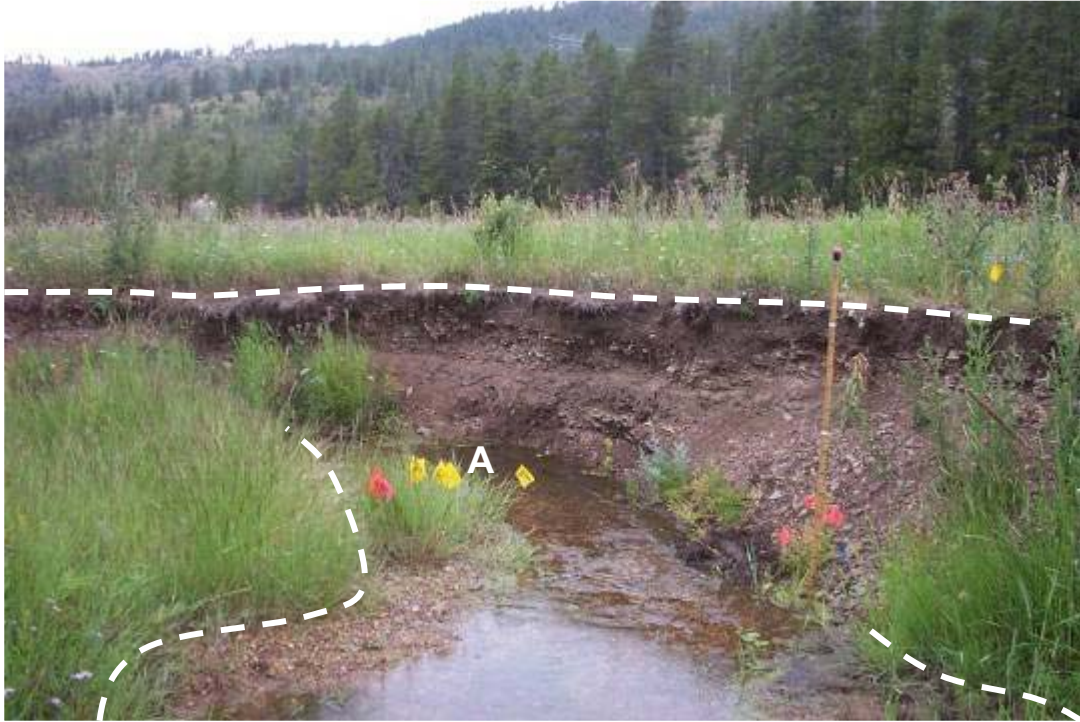
**Figure 23**—the greenline follows the relatively continuous line of vegetation. The vegetation near “A” is does not meet the greenline criteria of being at least 50 cm long. Photo - PIBO, U.S. Forest Service

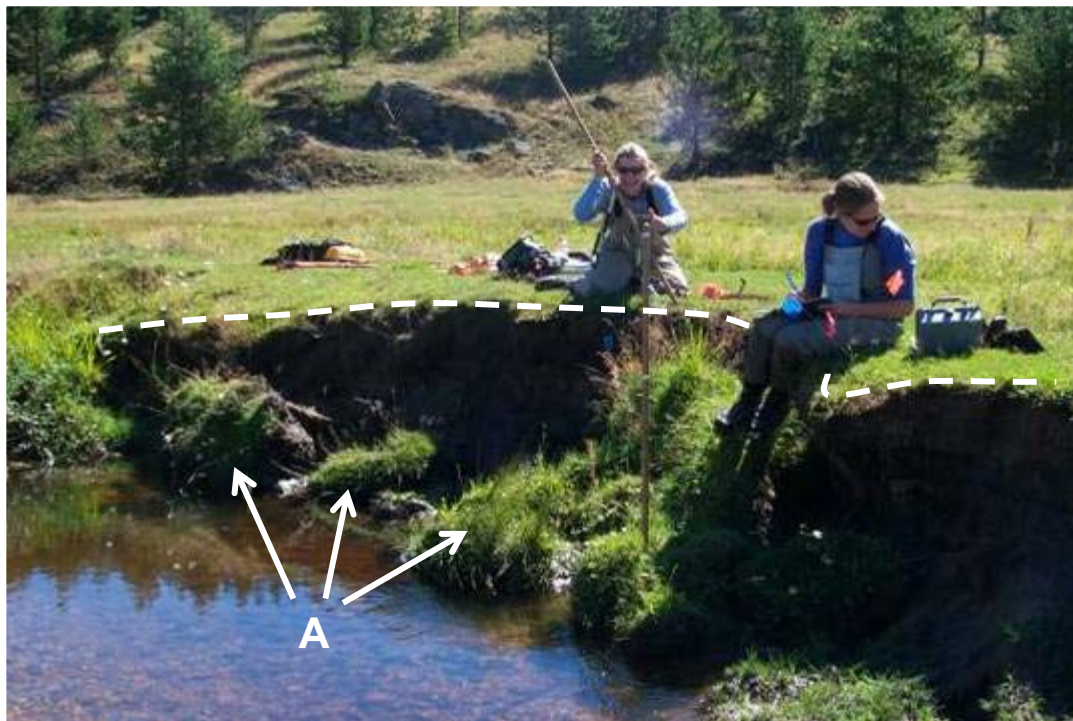
**Figure 24**—slump blocks “A” are detached and not considered part of the greenline. The dashed line shows greenline. Photo - PIBO, U.S. Forest Service

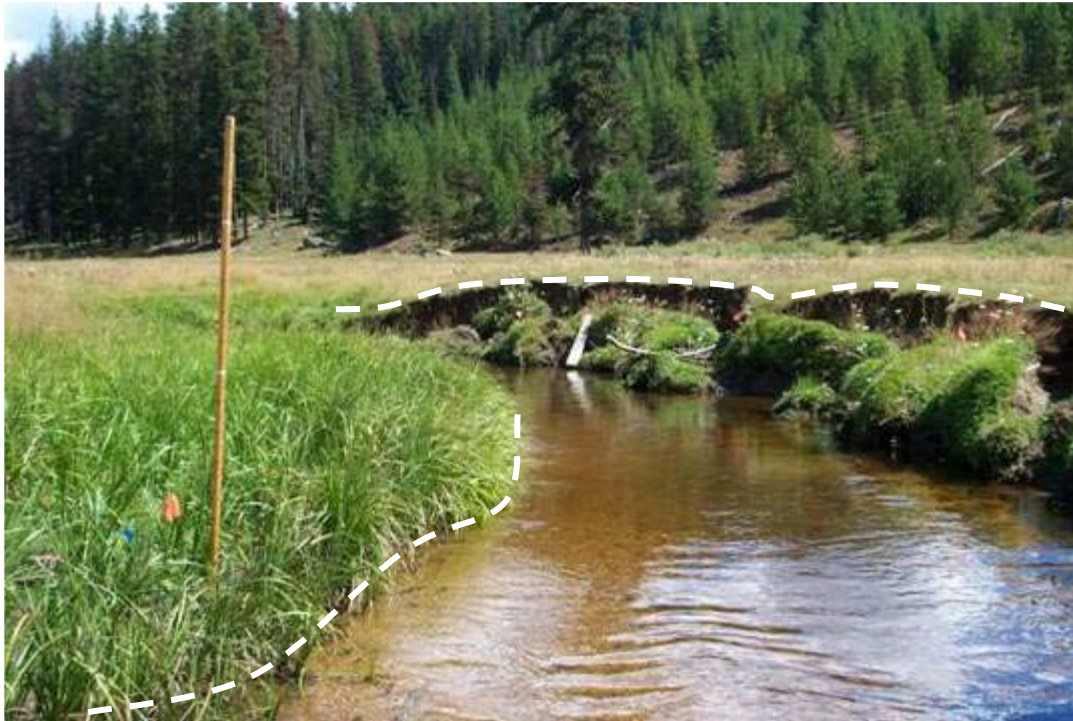
**Figure 25**—slump blocks along the far streambank are not attached by vegetation the terrace wall. *Photo - PIBO, U.S. Forest Service*

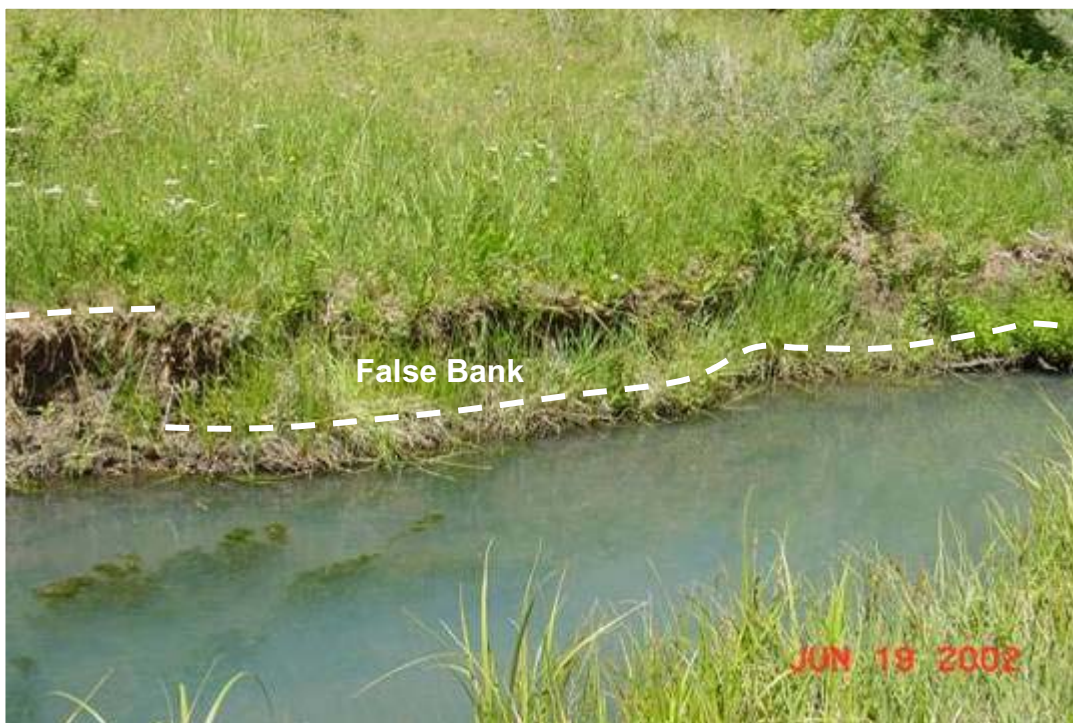
**Figure 26**—false bank is a slump block that is reattached and with vegetative cover. The slump feature is reattached to the streambank. The greenline follows the lower elevation vegetation.
